PROJECT PROFILE: 35 Dunham Road Office Building - Billerica, MA *Masonry Restoration and Structural Stabilization*

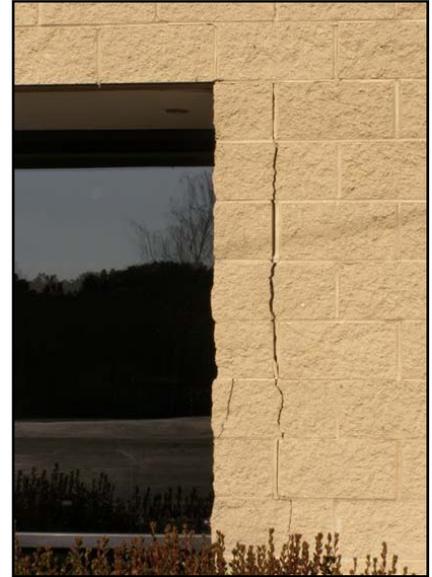
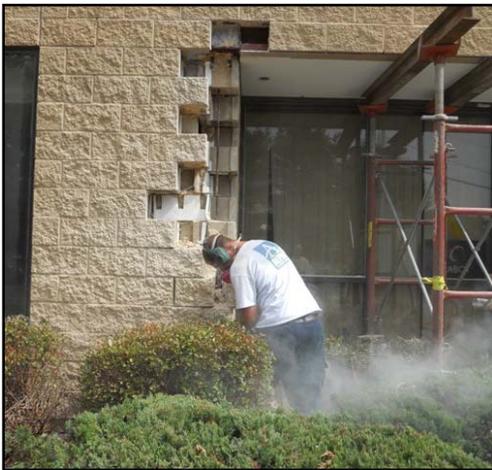
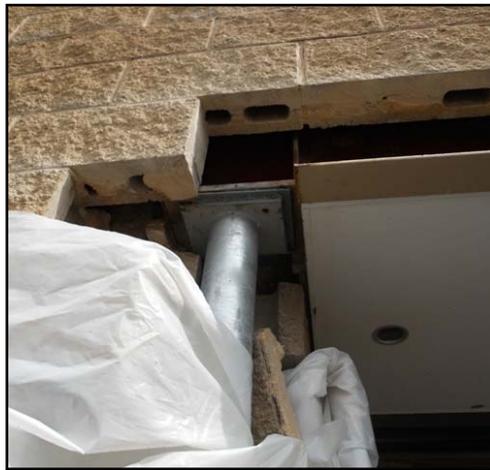
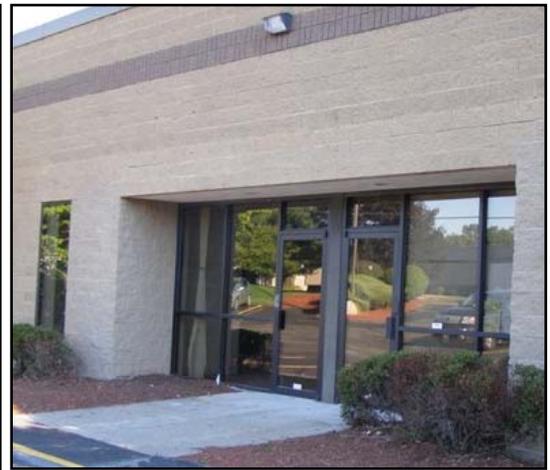
A single story load-bearing block masonry building that houses 14 individual business units had **extensive vertical cracking at the corners of each entryway**. The cracking was evident at all of the building entrances, and was determined to be a **significant structural issue** for the owners to address.

Once the test cut locations were explored and the engineer reviewed the existing construction, it was determined that a combination of **two factors** had caused the cracking: ***Excessive point loading*** on the masonry and ***reinforcing steel grouted in the corners had started to rust and expand***, pushing out on the masonry.

The successful repair solution was to **install a full-height structural tube column at each corner to transfer the loads down to the foundation** instead of through the masonry wall.

Alpha installed temporary shoring to support the existing steel beam across each entrance. The shoring needed to be sufficient to carry the existing building loads. Once the shoring was in place, Alpha was able to “tooth-out” the cracked masonry at each corner for the column installation. After the masonry was removed, the **new tube column was installed and welded into place**. The **replacement masonry had to be carefully notched** around the new columns so as not to alter the building lines.
