Carbon Fiber Strengthening of Masonry Walls *Albert N. Parlin School – Everett, MA*

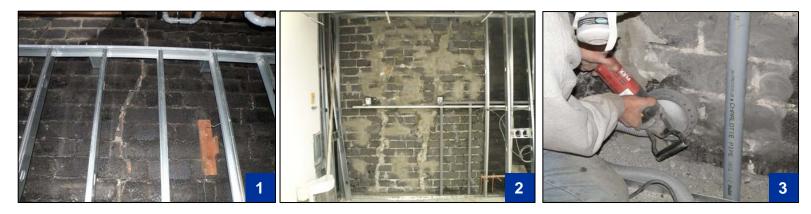
Photo 1: Routine construction had exposed failed, separated masonry in the interior brick walls on two levels of the Parlin school.

- Photo 2: All voids and cracks were filled with SikaGrout 212 by forming and pouring, or the dry pack method. Smaller cracks were injected with Sika epoxy of various viscosities.
- Photo 3: Dustless grinding was performed to level the surface and remove small projections on the surface.
