**PROJECT PROFILE:**  
**Anchorage Apartments - Charlestown, MA**  
*Historic Restoration of Roof and Gutter System*

**Property Owner:** Barkan Management Company

**Architect:** Wessling Architects

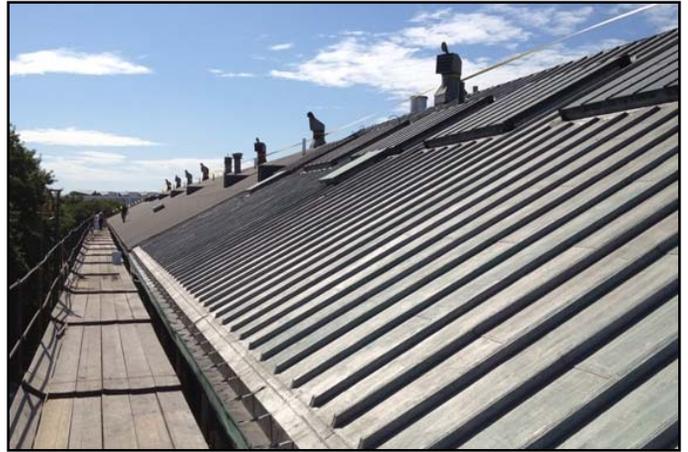
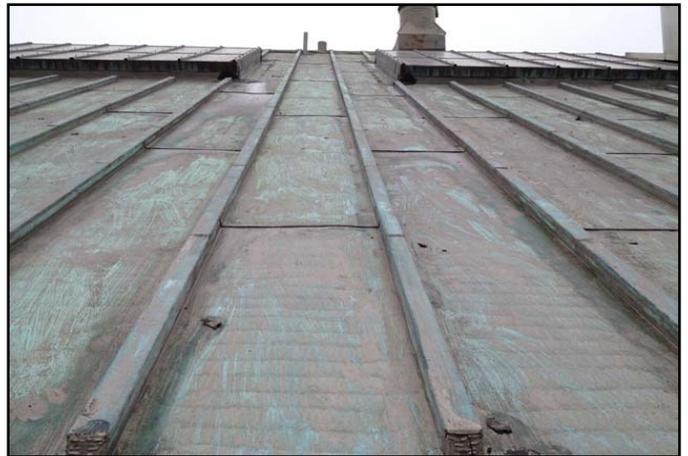
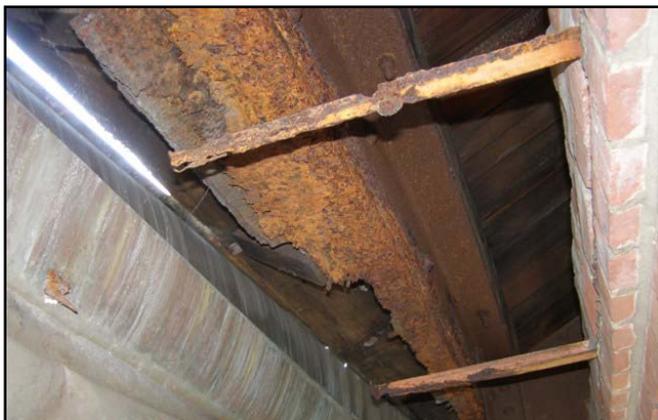
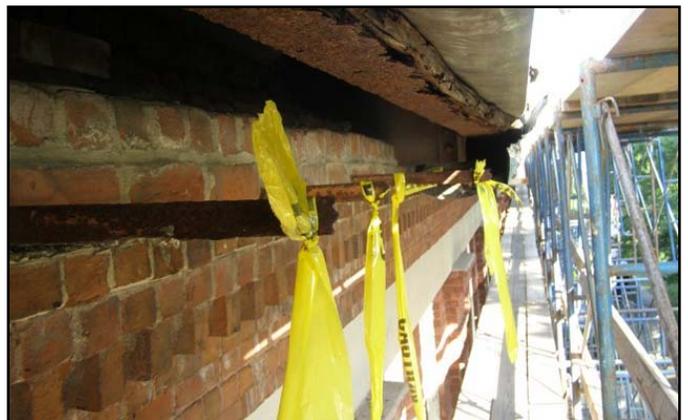
The Anchorage Apartments is an extremely long building at 460-ft., and required a substantial amount of staging just to access the roof and cornice area. The building had been experiencing recurring roof leakage and the owner wanted to resolve it as well as address concerns at the cornice area where sections of the ornate copper work had become displaced and in some locations were missing.
