## **Challenges of a Building Envelope Restoration Contractor**

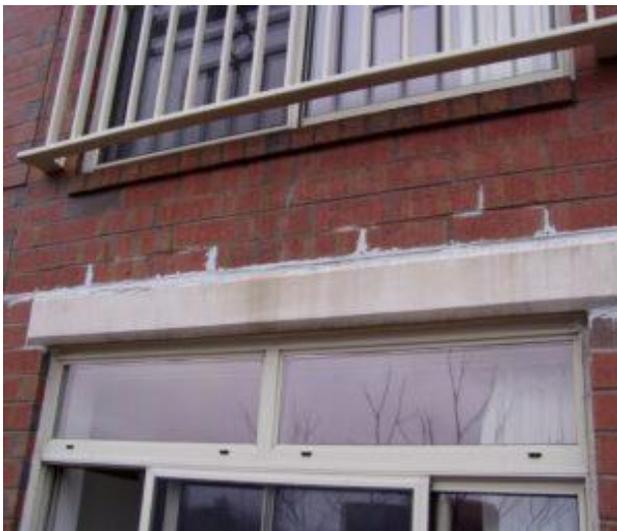
*Faulty flashing discovered as source of persistent slider leak after improper caulking of lintel and weep holes.*

In many cases, if a building is experiencing localized leaking, running some limited water tests to recreate the situation provides insight that allows a quality waterproofing contractor to implement a long-term repair that resolves the issue for the building. Although this approach may be slightly more expensive initially, the testing and investigation process can eliminate the cost of paying to repair the same location multiple times.

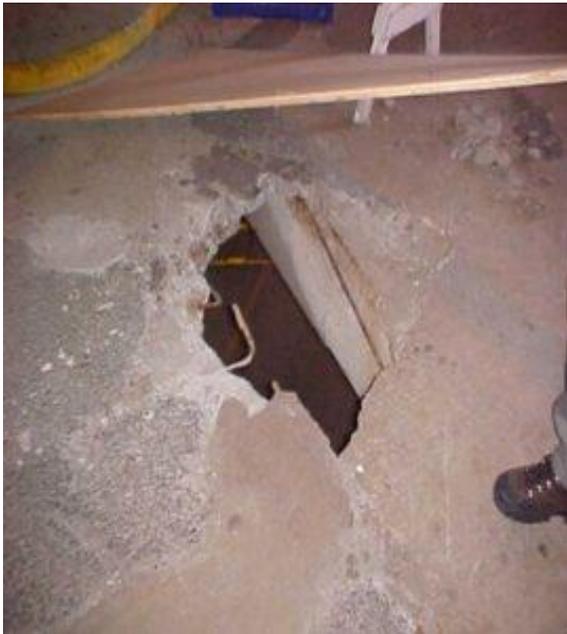
*Pictured: Emergency shoring required after years of concrete deck deterioration and failed pothole repairs in a second-floor parking garage.*
