PROJECT PROFILE: 35 Dunham Road Office Building - Billerica, MA *Masonry Restoration and Structural Stabilization*

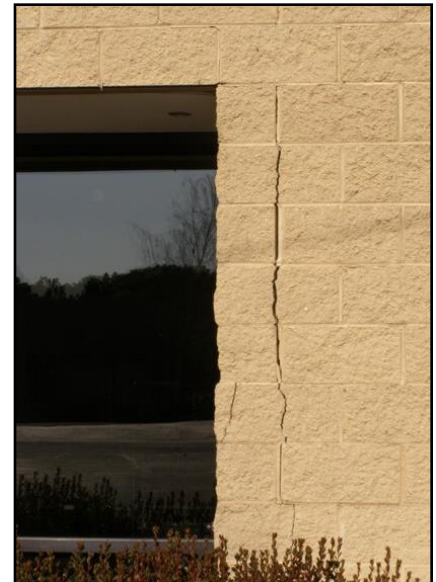
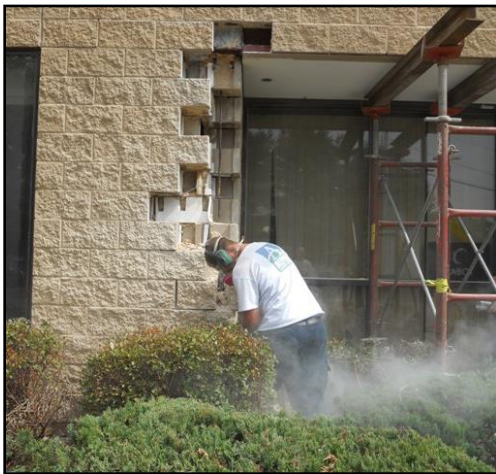
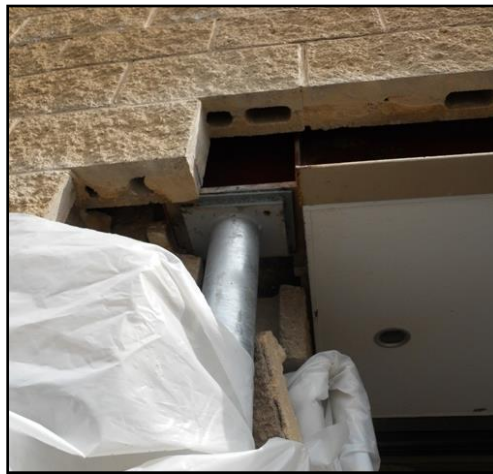
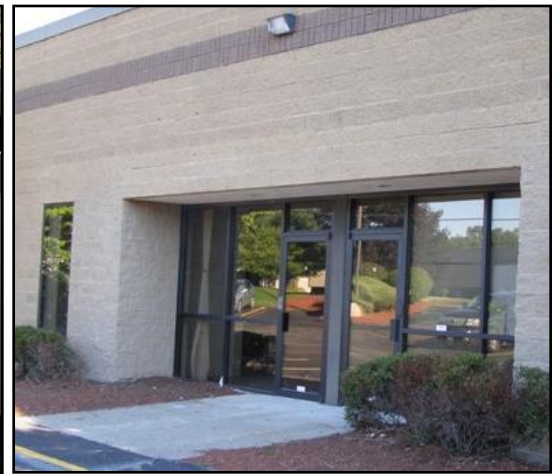
A single story load-bearing block masonry building that houses 14 individual business units had **extensive vertical cracking at the corners of each entryway**. The cracking was evident at all of the building entrances, and was determined to be a **significant structural issue** for the owners to address.

Once the test cut locations were explored and the engineer reviewed the existing construction, it was determined that a combination of **two factors** had caused the cracking: **Excessive point loading** on the masonry and **reinforcing steel grouted in the corners had started to rust and expand**, pushing out on the masonry.

The successful repair solution was to **install a full-height structural tube column at each corner** to **transfer the loads down to the foundation** instead of through the masonry wall.

Alpha installed temporary shoring to support the existing steel beam across each entrance. The shoring needed to be sufficient to carry the existing building loads. Once the shoring was in place, Alpha was able to “tooth-out” the cracked masonry at each corner for the column installation. After the masonry was removed, the **new tube column was installed and welded into place**. The **replacement masonry had to be carefully notched** around the new columns so as not to alter the building lines.
