Waterproofing Success using Kemper System *Crown Point Condominiums – Swampscott, MA*

OWNER: Crown Point Condominium Association
CONTRACTOR: Alpha Weatherproofing Corp.
REPAIR MATERIAL: Kemper System

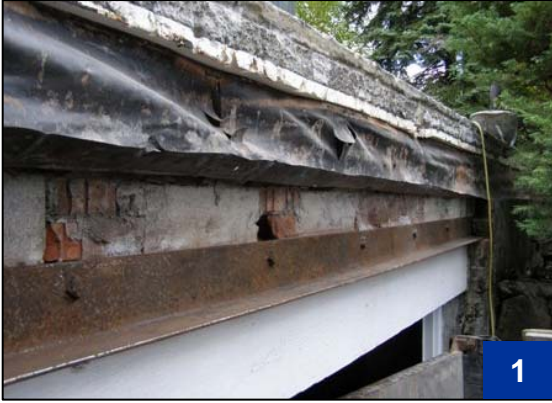
Photo 1:

Failed flashing and structural problems had created leaks that allowed water to penetrate and compromise the deck structure.
