Adhesion Testing & Flexible Coating Solution

Waterproofing Success at Lyne Labs – Brockton, MA

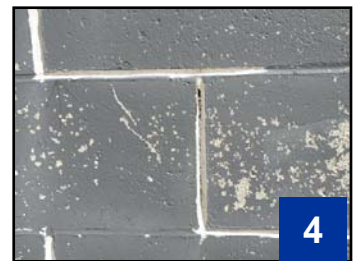
- 1) Exterior of block building with water penetration to the building interior through cracks in the mortar joints
- 2) Surface preparation tests using high pressure water
- 3) Sika representative performs adhesion tests using ASTM D 3359-02
- 4) Every crack was opened using the dry cut saw method to form a small working joint
- 5) Cracks were then sealed with Sikaflex 1A, a single-component polyurethane elastomeric sealant
- 6) All sealant joints were then hand-detailed with Sikagard 550W Elastocolor tint base to prevent the sealant from shadowing through the coating
- 7) After detailing the base coat, the top coat was applied using Sikagard 550W Elastocolor that had been tinted white
- 8) **The RESULT: A leak-free structure with a 5-year Sika warranty**
