PROJECT PROFILE:

Waterproofing Success at Watermill Place Condominiums - Arlington, MA

Property Manager: Barrington Management Inc.
General Contractor: Alpha Weatherproofing Corp.

Engineer: CBI Consulting Inc.
Waterproofing Manufacturer: Tremco Incorporated

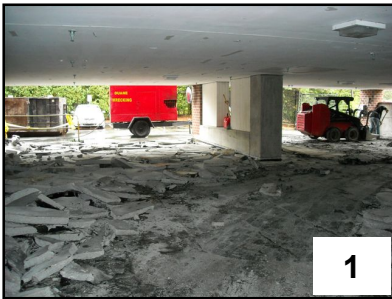
1

PREPARATION (Photo 1)

- Reinforced plastic was erected under the slab to prevent leaking or damage to cars
- The topping slab was removed
- The failed membrane was removed and the surface was prepped using hydrodemolition

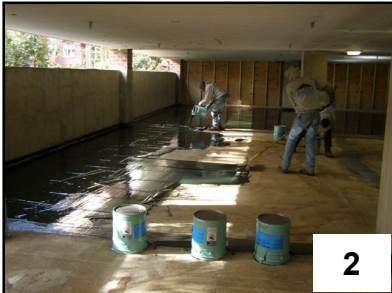
2

MEMBRANE WATERPROOFING (Photo 2)

- Cracks were saw cut, sealed and detailed
- Waterproofing was applied with gage rakes to ensure the proper mil thickness

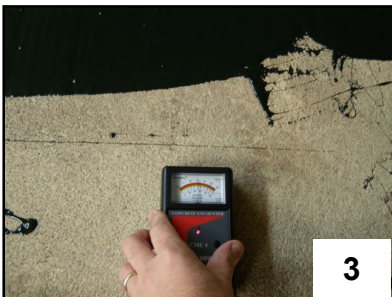
3

TESTING (Photo 3)

- Numerous moisture tests were performed to ensure positive application
- Drains were plugged and a 24-hour water test was conducted

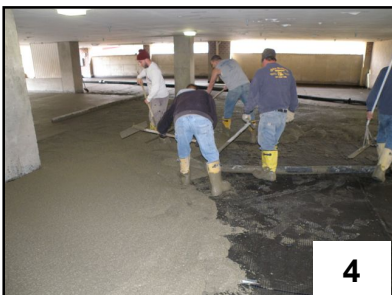
4

CONCRETE POUR: (Photo 4)

- A special protection course/drainage mat was installed
- 1.5-inch macro fiber reinforcement was added to the concrete to prevent cracking
- Line stripes and brick walkways were installed to complete the project
